## Research Case Study

# Stream Restoration that Allows for Self-Adjustment Can Increase Channel-Floodplain Connectivity

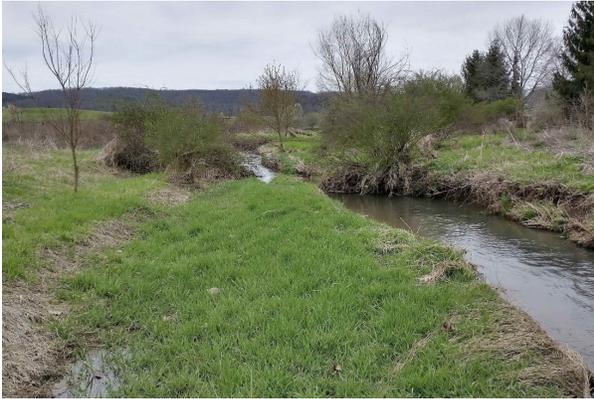
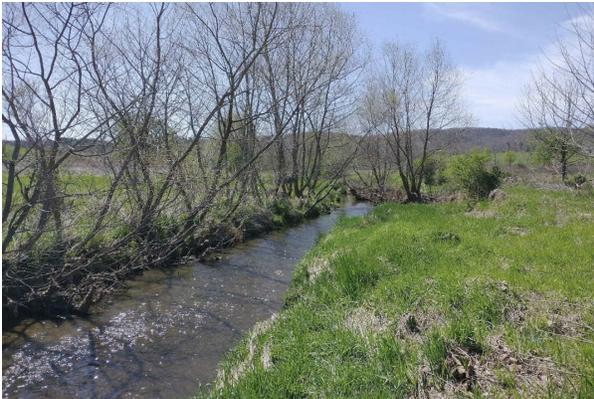
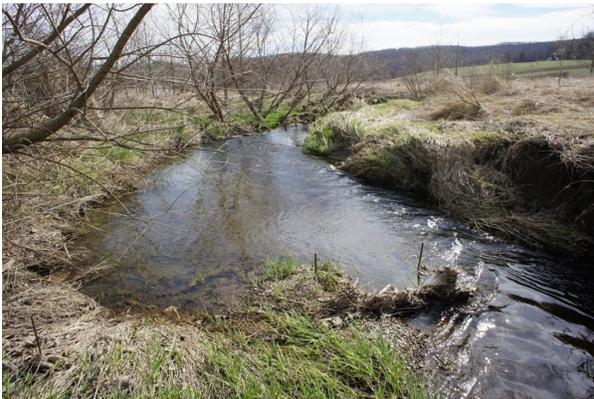
**Project photographs** Treatment 1, photographed April 2022: Excluded cattle only. Treatment 2, photographed April 2022: Banks were regraded to a 3:1 slope, stabilized, and replanted with native species; also excluded cattle. Treatment 3, photographed April 2018: Inset floodplain was cut into the bank; the banks were then regraded to a 3:1 slope, stabilized, and replanted with native species; also excluded cattle. Photographs from 2010 and before are available in Wynn-Thompson et al. (2010).

Treatment 1 (valley length 480 m) was passively restored by removing cattle using fencing. The 2 reaches downstream (Treatment 2: 510 m and Treatment 3: 300 m) also excluded cattle and were actively restored by regrading and stabilizing the vertical streambanks without in-stream construction (Fig. 2). After regrading, these actively restored treatments of the stream were stabilized with native vegetation and coir fiber matting. The banks of Treatment 2 were regraded from nearly vertical to a 3:1 slope. Treatment 3 had a 2-stage channel design (or inset floodplain) with a lower bench between 0.4 m – 0.5 m above the thalweg, then sloped 3:1 to an elevation of approximately 0.7 m – 0.8 m above the thalweg, which was then sloped to the upper floodplain elevation (Wynn-Thompson et al. 2010; Resop et al. 2014; Hendrix 2022).

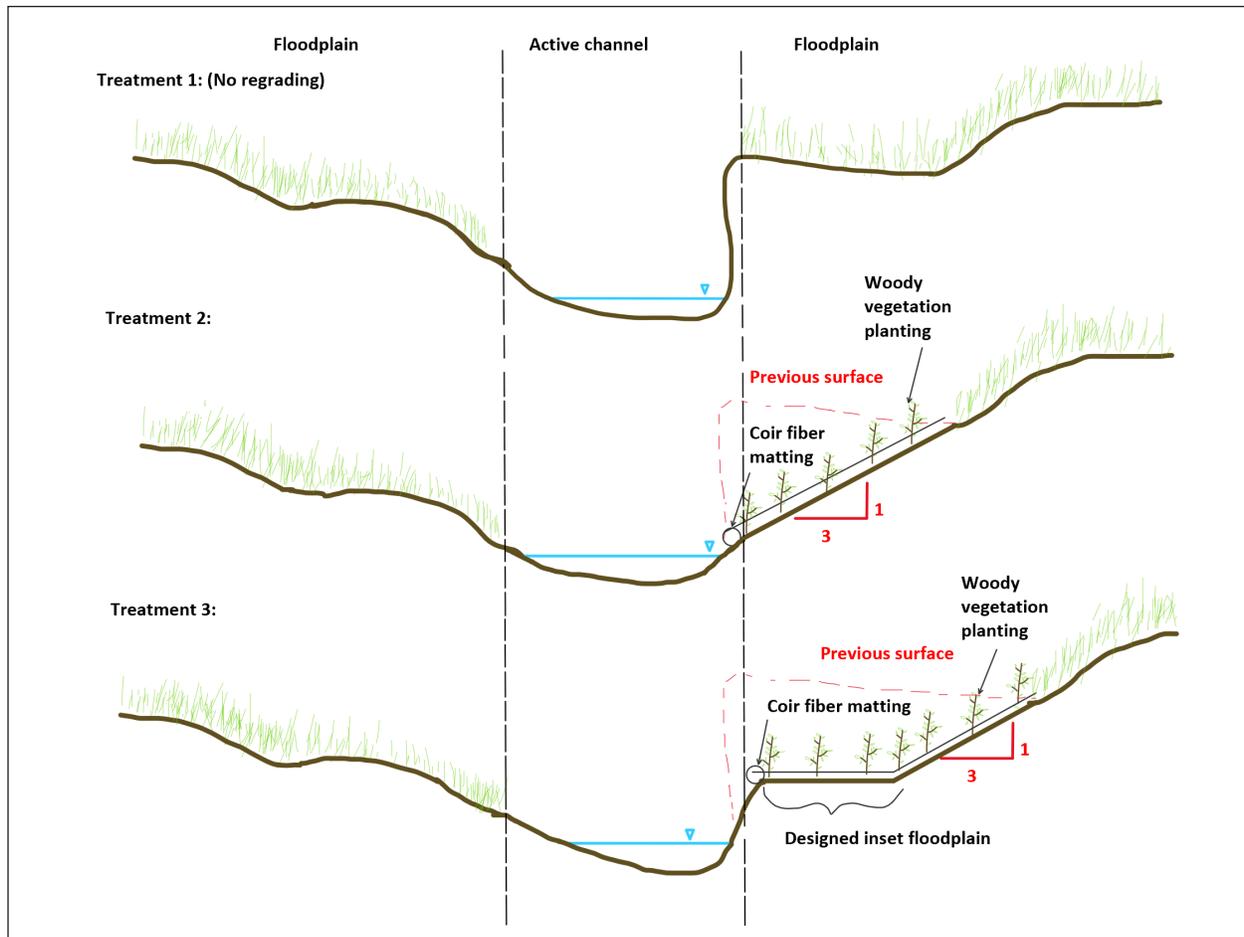
**Fig. 2** Conceptual diagram of cross sections immediately after restoration treatments were applied (not to scale).

Treatment 1 has the highest stream slope at 0.30% and the highest sinuosity at 1.15. Treatment 2 has a lower stream slope and sinuosity at 0.20% and 1.05, respectively. Treatment 3 has intermediate values between Treatments 1 and 2 with stream slope and sinuosity of 0.25% and 1.13, respectively. Regrading efforts were focused on changing cross-sectional geometry, meaning these differences in longitudinal and planform geometry are due to the pre-restoration conditions and post-restoration adjustment. For this study we delineated the

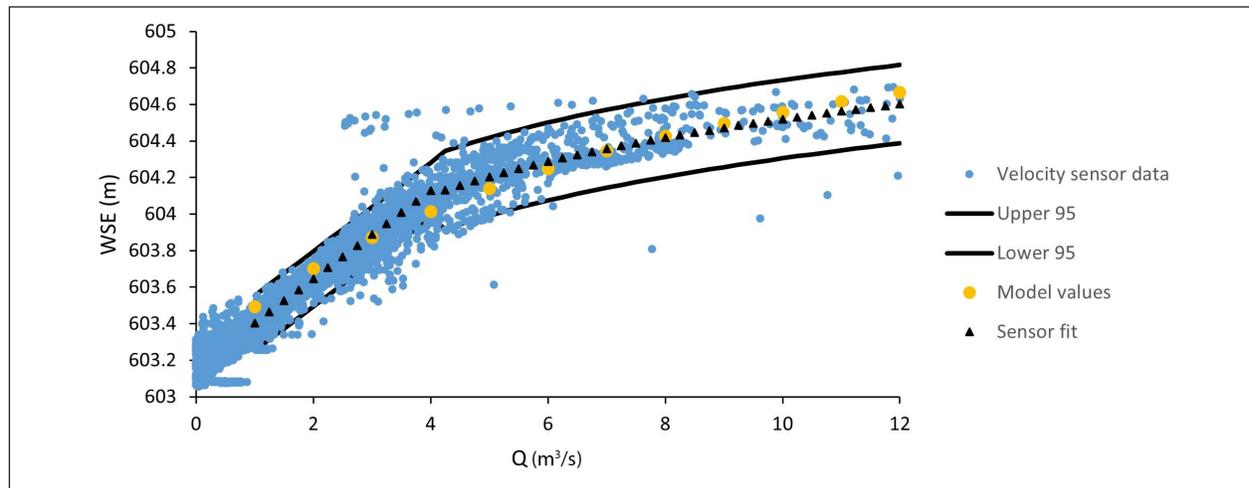
**Fig. 3** Calibrated model results, simulated streamflow (Q) and water surface elevation (WSE) data compared to the observed data from the in situ velocity sensor at Bridge 2 along with the piecewise fit to the sensor data.

Calibration to the observed streamflow (Q)-(WSE) relationship yielded best-fit roughness values of 0.05, 0.45 and 0.04 for the channel, floodplain, and access path, respectively. The fully calibrated model produced a RMSE of 5.6 cm with all modeled flows falling within the 95<sup>th</sup> prediction interval of the collected data (Fig. 3).

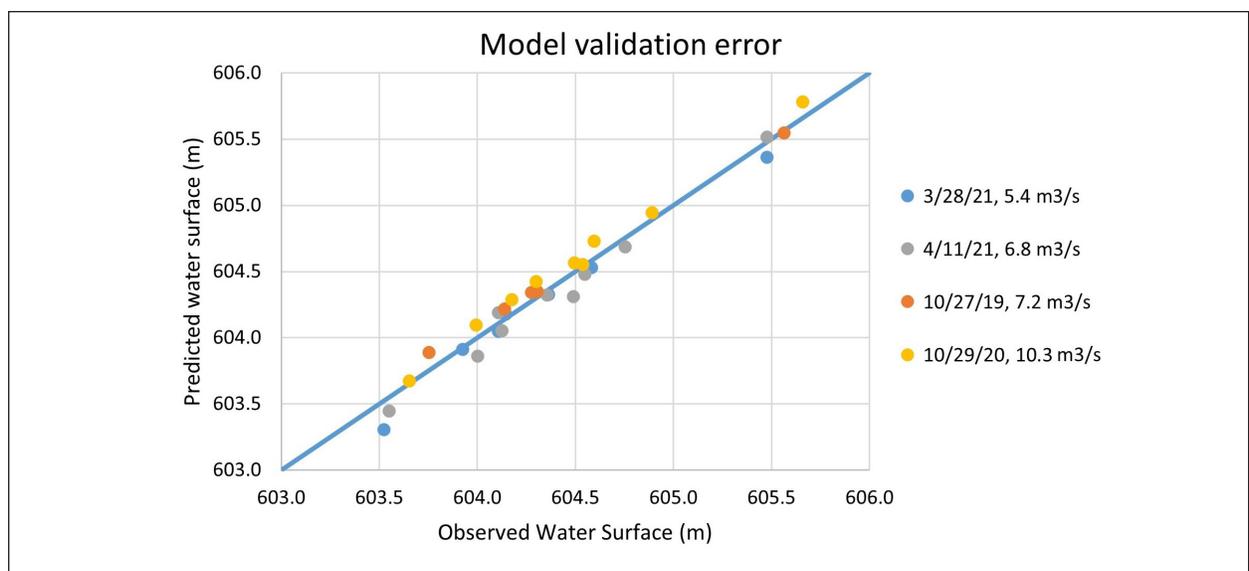
**Fig. 4** Evaluation of model comparing the predicted water surface to the pressure transducer observations.

The 4 evaluation runs of observed peak flows had an RMSE of below  $10 \text{ m}^3/\text{s}$  (Fig. 4). These runs showed less accuracy than the calibration runs, likely because of spatial nonuniformity in roughness, which was spatially constant in the model over the 3 zones. All 4 evaluation runs showed acceptable error with the RMSE of each run below values found in a similar 2-D HEC-RAS model of the same reach with more complex characterizations of roughness (Prior et al. 2021).

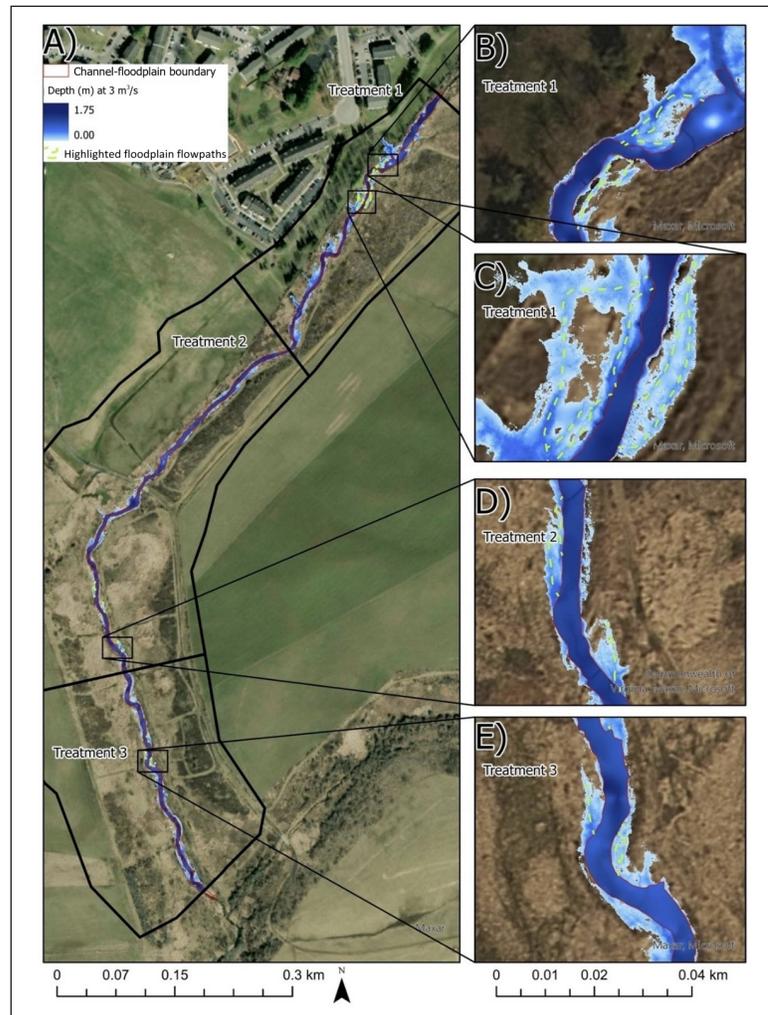
**Fig. 5** Simulated depths at  $3 \text{ m}^3/\text{s}$ . Key areas are highlighted to show the differences in flow paths within the floodplain for each treatment. ArcGIS Pro imagery from 2020. Sources: Esri, Maxar, Earthstar Geographics, and the GIS User Community.

Model simulations revealed that the floodplain channels of Treatment 1 are activated during flows as low as  $3 \text{ m}^3/\text{s}$  (Fig. 5B and Fig. 5C). While some small floodplain channels close to the main channel can be seen in Treatments 2 and 3, they are less numerous and widespread than in Treatment 1 (Fig. 5D and Fig. 5E). These floodplain channels usually spanned one meander length and brought water out onto the floodplain before quickly returning to the main channel.

The increased channel-floodplain connectivity observed in Treatment 1 is likely due to the low-lying inset floodplains, which were at least partially inundated at all modeled flows (pictured, planform in Fig. 5). The inundation of these features led to cross-meander flow contributing to high exchange rates between the channel and floodplain (Fig. 7). These well-connected inset floodplains also promoted flow thereby relieving maximum flows within the channel (Fig. 7B). The increased channel-floodplain connectivity of Treatment 1 was more pronounced during flows  $\leq 6$  m<sup>3</sup>/s, but during the largest floods some metrics showed that Treatment 3 had similar channel-floodplain connectivity (Fig. 7). When comparing the regraded treatments, Treatment 3 had a higher floodplain volume and flow moving through the floodplain compared with Treatment 2 (Fig. 7A). This was probably due to the inset floodplain created in Treatment 3.

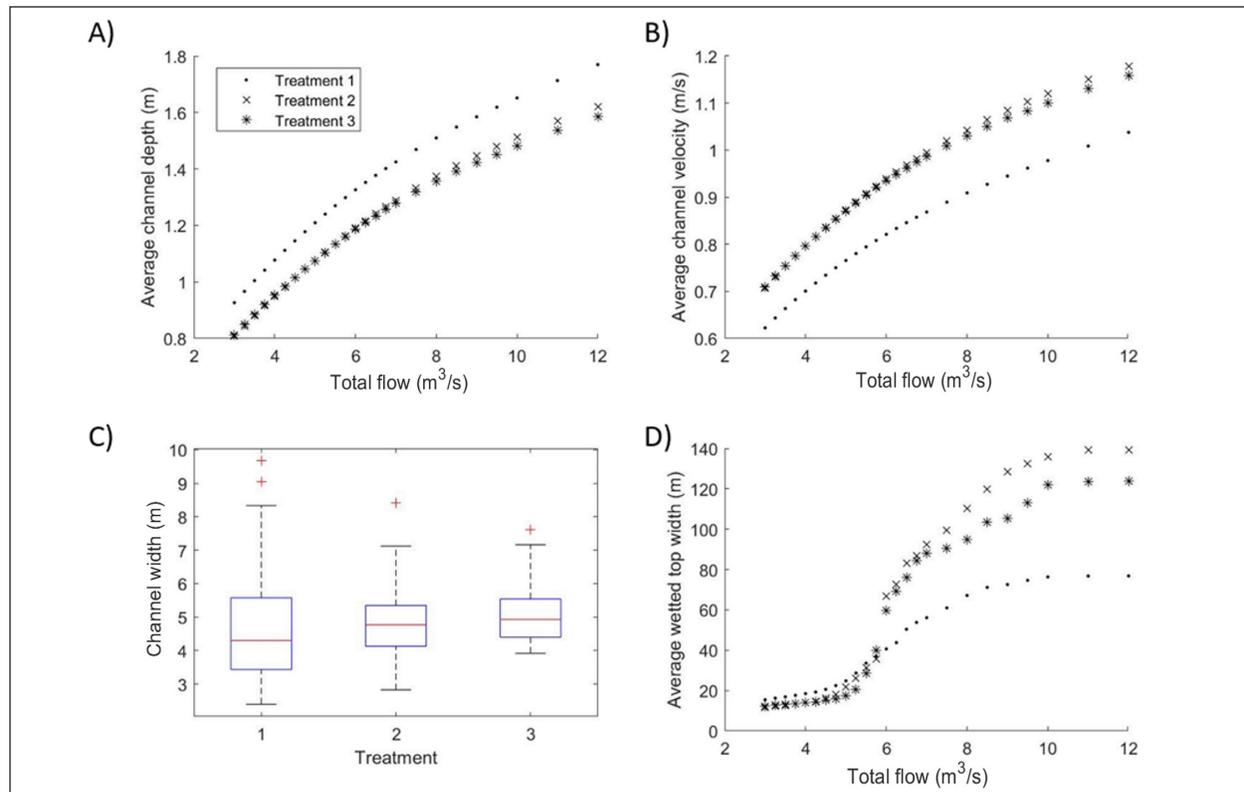
**Fig. 6** Flow and channel characteristics of each treatment in 2021 (11 yrs after restoration) over the range of modeled flows including: A) average depth within the channel; B) average velocity in the channel (note that Treatments 2 and 3 plot nearly on top of each other); C) channel width median, 25<sup>th</sup> percentile, 75<sup>th</sup> percentile, maximum and minimum data not considered outliers, and outliers; and D) average wetted top width.

Flow in Treatment 1 was on average deeper and slower moving than flow in Treatments 2 and 3 (Fig. 6A and Fig. 6B). The velocities in Treatment 3 are nearly the same as observed in Treatment 2 (Fig. 6B). Though the median channel width of Treatment 1 is smaller, moderate floods ( $\leq 6 \text{ m}^3/\text{s}$ ) inundate a larger width, likely due to the low-lying inset floodplain in Treatment 1 (Fig. 6C and Fig. 6D). During large floods the entire valley is inundated and the wetted widths of Treatments 2 and 3 overtake that of Treatment 1. This points to a wider main valley in Treatments 2 and 3 (Figure 6D).

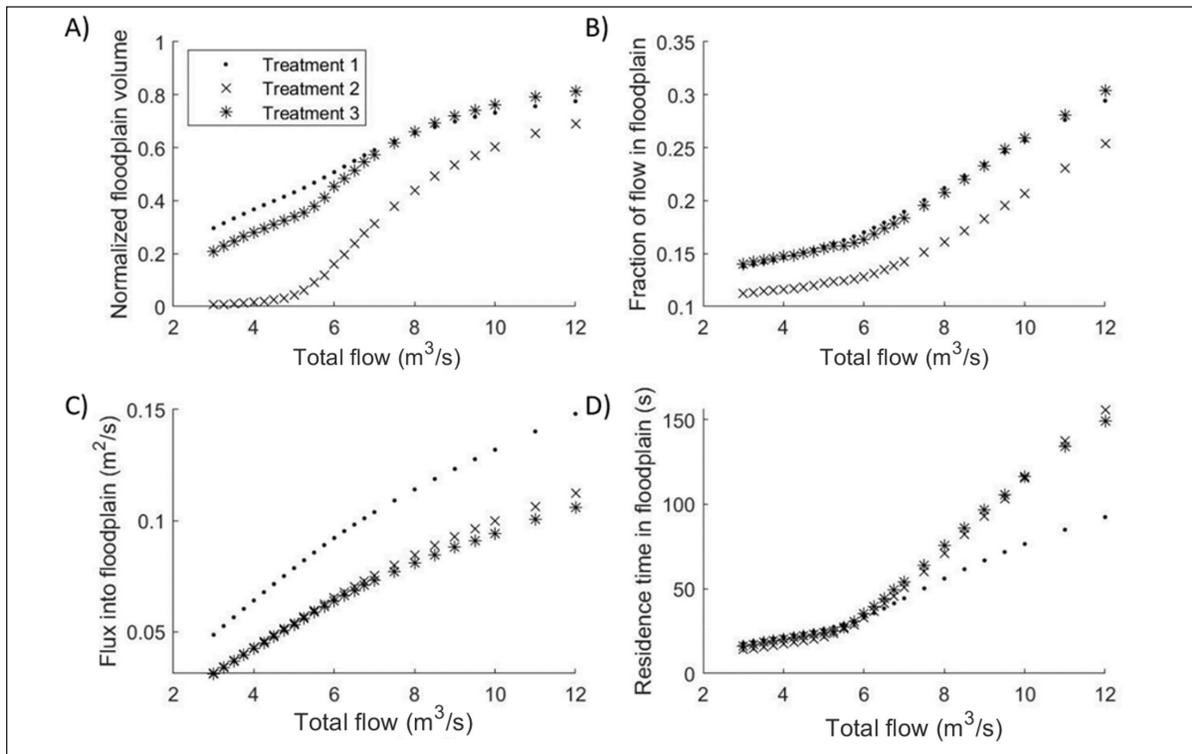
**Fig. 7** Channel-floodplain connectivity metrics for each section including: A) normalized floodplain volume, B) fraction of discharge in the floodplain, C) volumetric flux into the floodplain per unit length of stream, and D) residence time in the floodplain.

The calculated metrics for channel-floodplain connectivity (normalized floodplain volume, fraction of flow in the floodplain, and channel-floodplain exchange) indicate that Treatment 1 has the highest channel floodplain connectivity, followed closely by Treatment 3, while Treatment 2 has consistently low connectivity (Fig. 7). The normalized volume of water in the floodplain (floodplain volume/channel volume) was higher in Treatment 1 than in either regraded treatment for lower magnitude flows (Fig. 7A). For flows  $>7 \text{ m}^3/\text{s}$ , the floodplain volumes for Treatment 1 and 3 were very similar, with Treatment 3 having up to 4% higher normalized floodplain volume than Treatment 1. At all flows, Treatment 2 had the
